NARRAGANSETT BAY DRAINAGE

Narragansett Bay Drainage

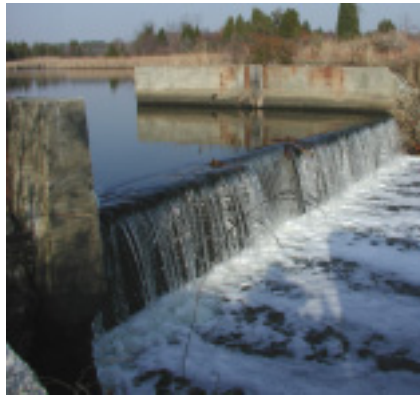
Dam on Mobil Corporation property

The Runnins River has three obstructions to passage along its relatively short course from wetlands in Seekonk to the Barrington River estuary. The first obstruction, the Mobil Dam, is on the Massachusetts/Rhode Island border and situated at the upper end of the Barrington River. This dam is within the influence of tidal fluctuations and is passable at higher tidal stages. A notch in the dam crest is currently blocked with a metal plate. Replacing this with wooden stop logs or a smaller plate to lower the notch invert would allow passage under a greater range of tailwater elevations.

Although river herring and possibly shad are currently utilizing the lower sections of the stream, further development is not practical due to difficulties in providing passage at the upper dams. The owner of the first dam should be approached with suggestions for altering the crest notch configuration.

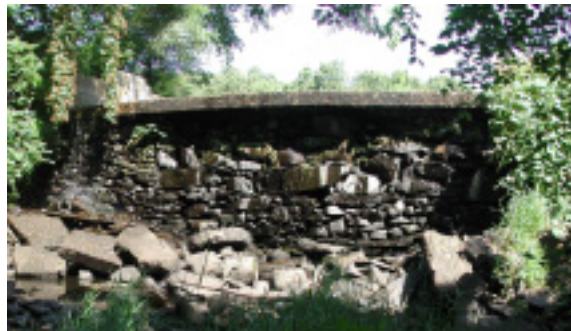
Burr Pond Dam

The second dam, at Burr Pond is not passable and, due to its height, would require a costly fishway installation not justified by the potential spawning area available in the upstream impoundment. A dam at the Old Grist Mill Pond, only a few hundred yards upstream, also obstructs fish passage. A fishway at this location would also be difficult to install given the structures in the vicinity of the dam.

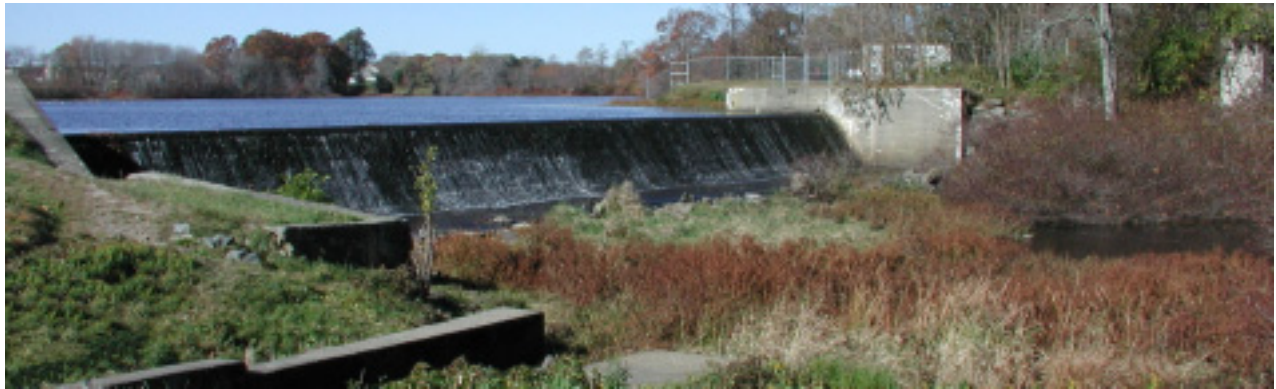
Shad Factory Pond Dam

Design	Material	Length (ft)	Inside W (ft)	Outside W (ft)	# of Baffles	Baffle H (ft)	Notch W (ft)	Pool L (ft)	Condition/Function
Weir-pool	Concrete	321.0	3.0	5.0	19	1.0	-	16.0	Poor Inefficient passage

The Palmer River flows from its source in the wetlands of northern Rehoboth to its confluence with the Barrington River. The river supports one of the few small stream American shad fisheries in the Commonwealth and the only one south of Cape Cod. In addition, an increasingly important river herring fishery exists here as do rainbow smelt and white perch populations. While herring utilize the fishway to spawn above the Shad Factory Pond dam, the other species successfully spawn in the section of river below the dam. The fishway at Shad Factory Pond has been known to pass small numbers of shad as well as river herring but its poor condition and collapsing walls may soon make it completely impassable. Designs for a similar weir-pool ladder have been prepared and the ladder will be replaced if funding can be acquired. Modifications to the dam in the form of a notch on the south side of the crest or stop logs across the north side would direct more flow to the fishway side of the tailwater pool, resulting in greater attraction to the fishway entrance. An obstructing deposit of sediments near the fishway entrance has recently been removed. The channel to the ladder should continue to be maintained and kept free of blockages to passage.

1. The focus of work in the Narragansett Bay watersheds should be on improving and maintaining the river herring and shad runs in the Palmer River. A source of funding for constructing and maintaining a new fishway at Shad Factory Pond must be found and the ladder then built. The owner of the dam, Bristol County Water Authority, should be encouraged to approve the suggested dam modifications, which will provide better attraction to the fishway entrance. The Town of Rehoboth should continue to develop and enforce, with the assistance of the state agencies, its local regulations for the river herring fishery.

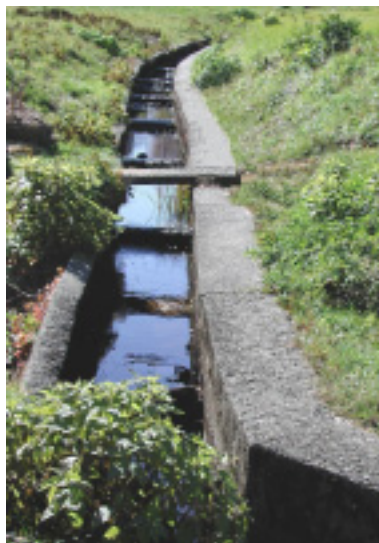
Lower Section of Ladder at Shad Factory Pond

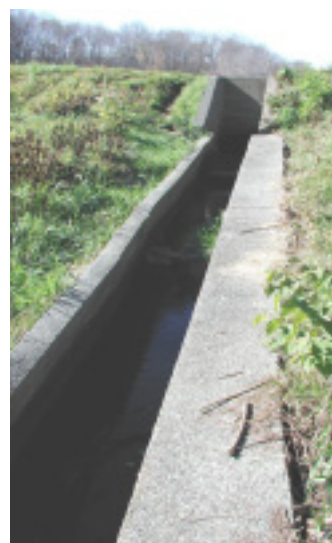
Fishway exit at Shad Factory Pond

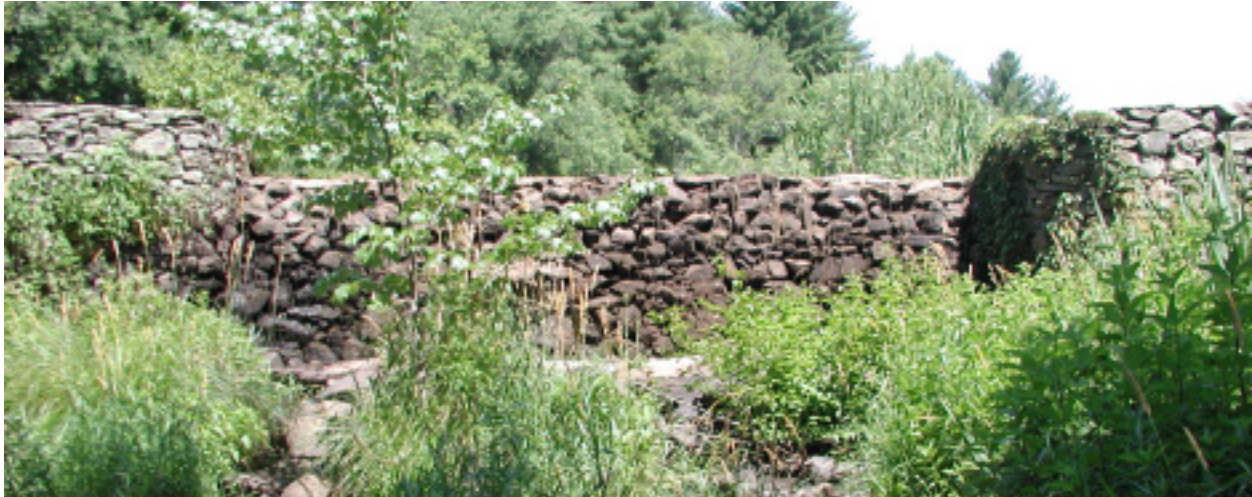
There is little value in providing fish passage at the Perryville Dam due to the lack of significant upstream habitat.

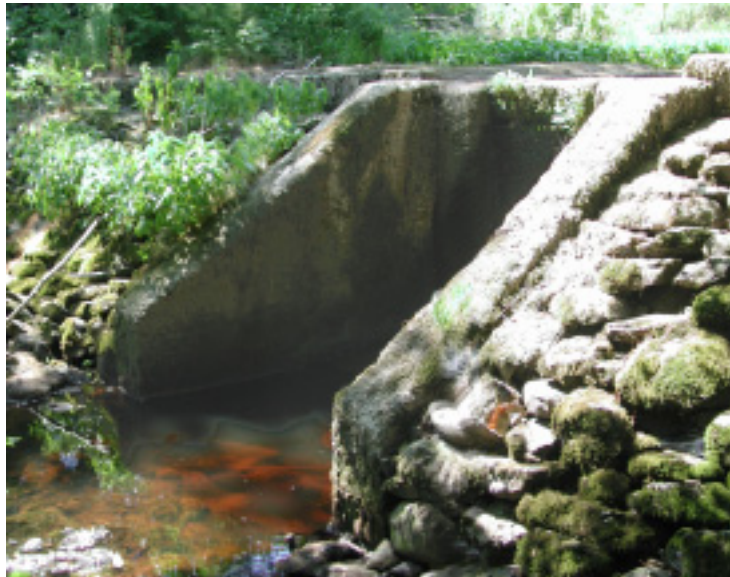
The East Branch of the Palmer River is obstructed by Village Dam at Bay State Road. The dam may be passable under some flow conditions due to a bypass channel on its east side. There is little spawning habitat available above the dam, however, and further development is a low priority.

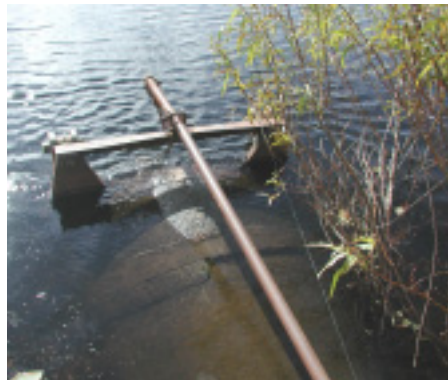
Unnamed Bristol County Water Supply Dam

A second dam, also owned by BCWA, is located at the upper reaches of the first impoundment. A 48 inch diameter culvert is equipped with a clapper valve and may be impassable.

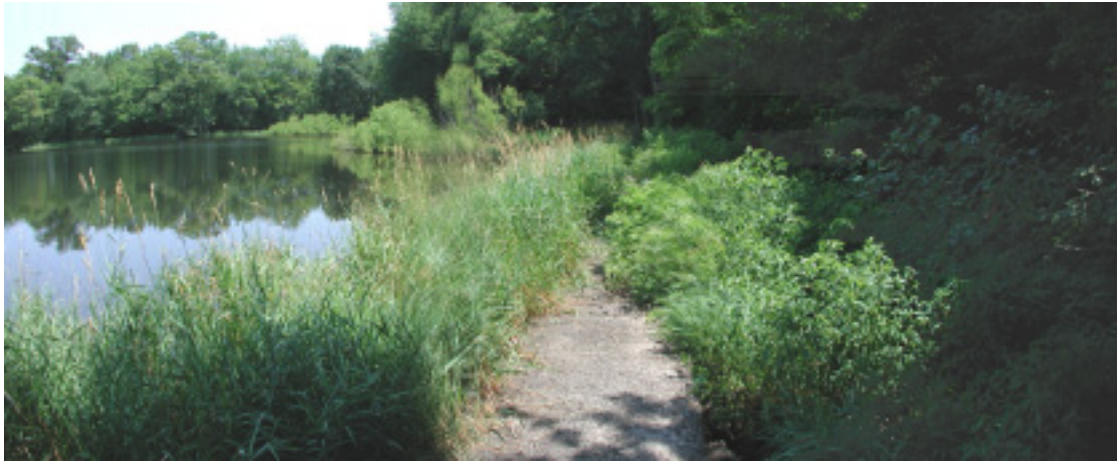
Warren Reservoir Dam

Warren Reservoir, the only spawning area in the Massachusetts portion of the watershed, is used as an auxiliary water supply by BCWA. No outflow other than seepage through the dam was observed at the time of the survey suggesting that potential for development of a river herring population is severely limited.

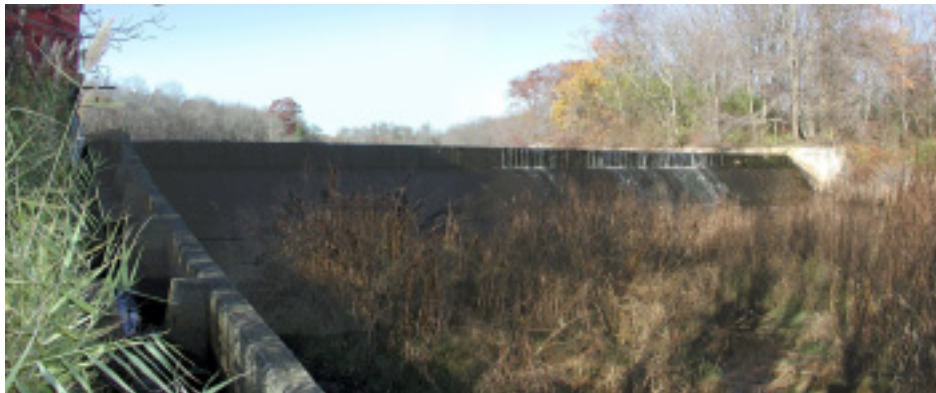
Cole Fishway Dam (with ladder along left side of spillway)

Design	Material	Length (ft)	Inside W (ft)	Outside W (ft)	# of Baffles	Baffle H (ft)	Notch W (ft)	Pool L (ft)	Condition/Function
Notched weir-pool	Concrete	63.8	3.0	4.3	6	Varied (2.0-4.1)	1.5	7.0	Fair Inefficient passage

Cole River supports a small river herring population and some smelt spawning has been observed below the first obstruction. Although equipped with a notched weir-pool fishway, fish passage at this location is inefficient. Deposited material and rooted vegetation in the tailwater area have eliminated any defined channel and most spillway flow is directed to the side of the stream opposite the ladder. With the resulting lack of attraction to the entrance, few fish actually ascend the ladder. In addition, the ladder design is inefficient and compounds the problem.

Montaup Electric Company, the owner of the dam and ladder, has been advised on methods to improve effectiveness of the fishway. Removal of deposited materials below the ladder entrance and redirection of crest flow to the fishway side by adding stoplogs at the opposite end of the dam would increase attraction to the ladder. Also, replacement of the fishway with a more efficient design or lining the existing ladder with aluminum steeppass sections would greatly improve its function.

3. Efforts to improve fish passage at the first dam on the Coles River should continue. A channel from the main stream to the ladder entrance should be established and the suggestions to modify the dam crest to direct flow the fishway side of the spillway should be followed. Consideration should be given to upgrading the existing ladder through step modification or lining the existing weir-pool with an aluminum steep pass fishway.

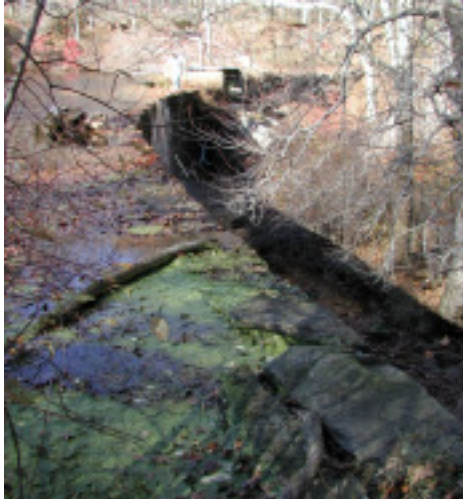
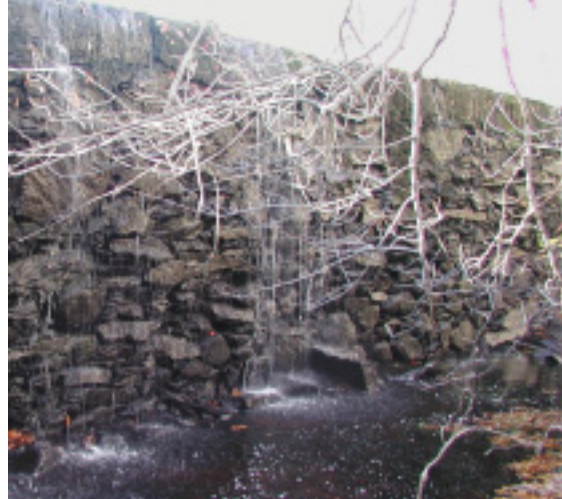
Milford Pond Dam

The second dam on this stream creates a relative large impoundment, which could significantly increase available habitat if it was made accessible. Once the problems at the lower dam have been corrected, consideration should be given to construction of passage facilities at the Milford Pond dam.
