NARRAGANSETT BAY DRAINAGE

Narragansett Bay Drainage

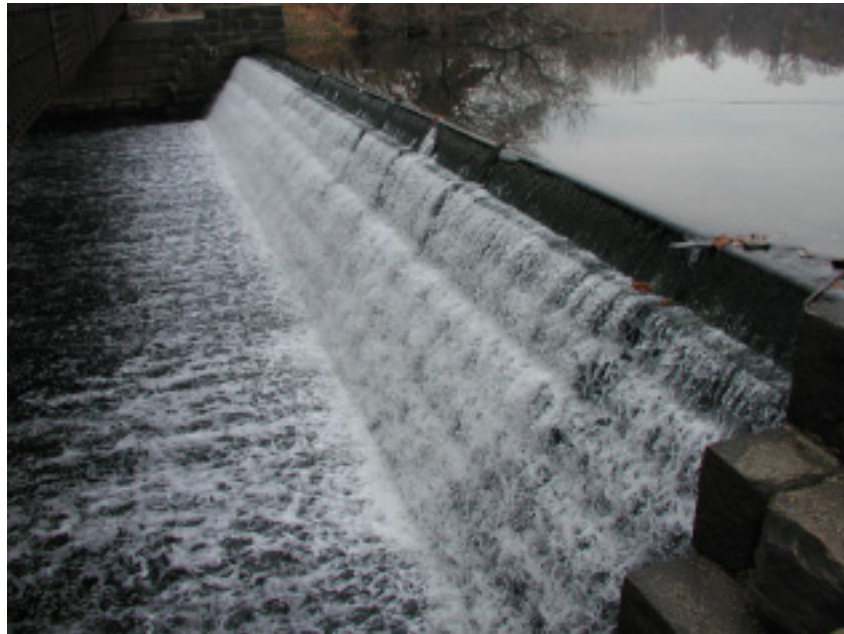
Obstruction # 1

River Mile	Type	Material	Spillway W (ft)	Spillway H (ft)	Impoundment Acreage	Year Built	Owner	GPS
0.0	Dam, stepped	Granite	115	10.9	30.2	-	-	41° 50' 19.524" N 71° 22' 07.072" W

Omega Pond Dam

Design	Material	Length (ft)	Inside W (ft)	Outside W (ft)	# of Baffles	Baffle H (ft)	Notch W (ft)	Pool L (ft)	Condition/Function
Denil	Concrete with wooden baffles	142.5	4.0	6.0	42	4.5	-	-	Pre-construction

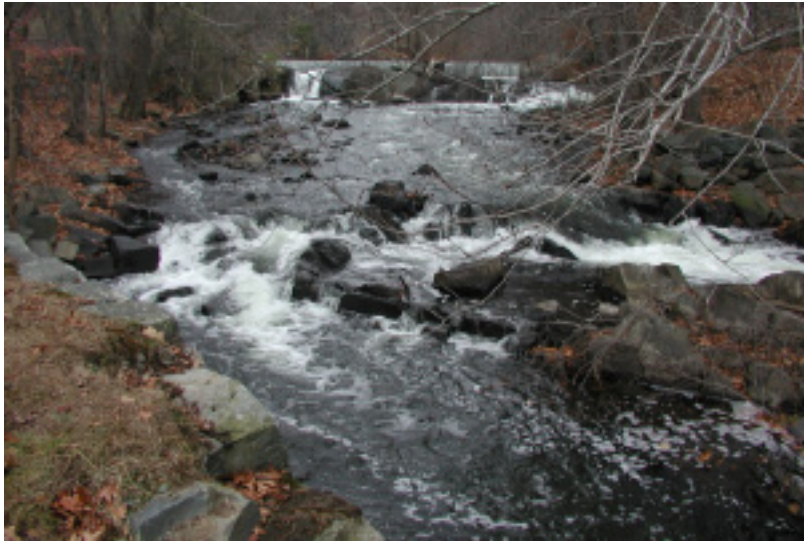
Obstruction # 2

River Mile	Type	Material	Spillway W (ft)	Spillway H (ft)	Impoundment Acreage	Year Built	Owner	GPS
2.1	Dam, semicircular	Stone	83	13.0	4.7	-	-	41° 49' 40.884" N 71° 20' 44.173" W

John Hunt House Dam

Design	Material	Length (ft)	Inside W (ft)	Outside W (ft)	# of Baffles	Baffle H (ft)	Notch W (ft)	Pool L (ft)	Condition/Function
Denil	Concrete with wooden baffles	137.5	4.0	6.0	29	Varied (5.0-7.0)	-	-	Pre-construction

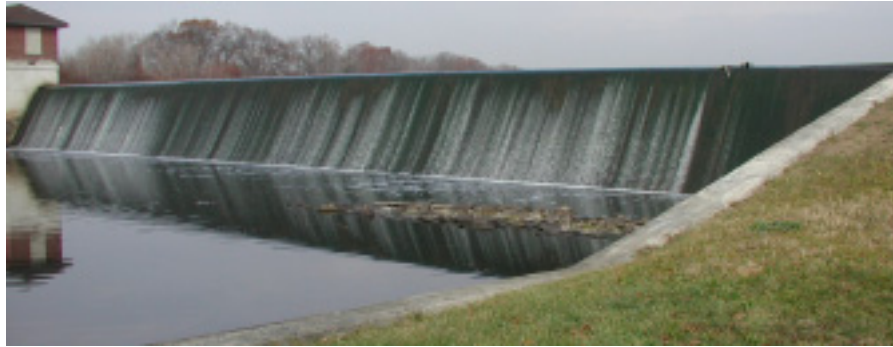
Obstruction # 3

River Mile	Type	Material	Spillway W (ft)	Spillway H (ft)	Impoundment Acreage	Year Built	Owner	GPS
2.5	Dam	Concrete spillway, stone and earthen berm	201	14.7	115.0	-	-	41° 49' 58.904" N 71° 20' 29.272" W

James Turner Reservoir Dam

Design	Material	Length (ft)	Inside W (ft)	Outside W (ft)	# of Baffles	Baffle H (ft)	Notch W (ft)	Pool L (ft)	Condition/Function
Denil	Concrete with wood baffles	165.8	4.0	6.0	45	5.0	-	-	Pre-construction

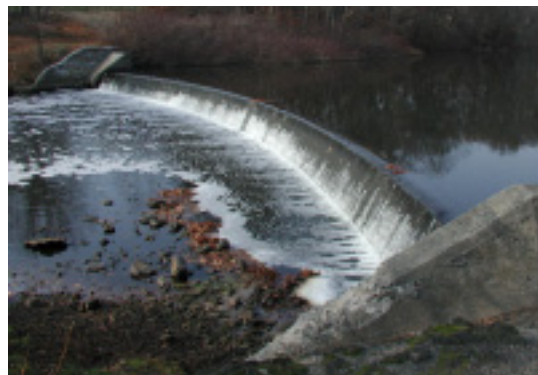
Obstruction # 4

River Mile	Type	Material	Spillway W (ft)	Spillway H (ft)	Impoundment Acreage	Year Built	Owner	GPS
5.6	Dam, semicircular	Concrete and stone	129	4.2	21.7	-	-	41° 52' 28.485" N 71° 20' 26.173" W

Ten Mile River State Park Dam

Fishway None

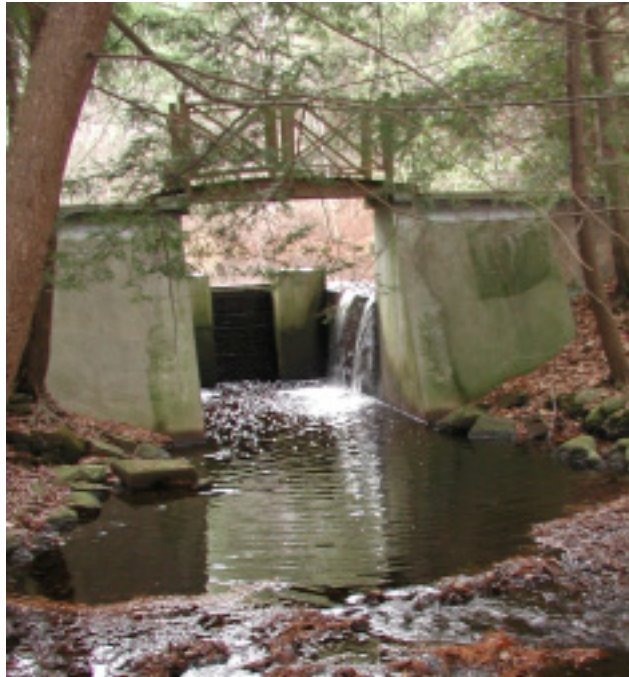
River Mile	Type	Material	Spillway W (ft)	Spillway H (ft)	Impoundment Acreage	Year Built	Owner	GPS
0.4	Dam	Concrete with wooden boards	3.0	5.0	0.6	-	Private	41° 50' 28.784" N 71° 14' 02.153" W

Bad Luck Brook Dam

Fishway None

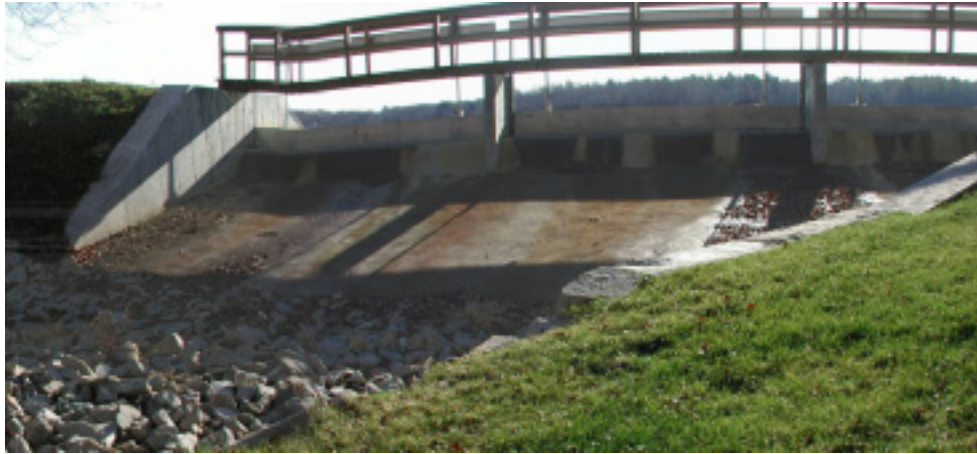
River Mile	Type	Material	Spillway W (ft)	Spillway H (ft)	Impoundment Acreage	Year Built	Owner	GPS
1.7	Dam	Concrete with aluminum stop logs	55.7	7.9	137.6	1912	Anawan Club	41° 49' 47.977" N 71° 13' 25.734" W

Upper Warren Reservoir Dam

Fishway None

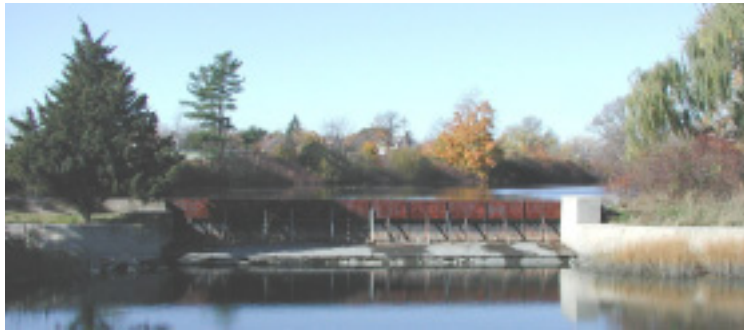
River Mile	Type	Material	Spillway W (ft)	Spillway H (ft)	Impoundment Acreage	Year Built	Owner	GPS
2.4	Dam	Concrete and steel	55	5.3	25.6	-	-	41° 43' 45.881" N 71° 15' 47.516" W

Bristol County Water Supply Dam

Fishway None

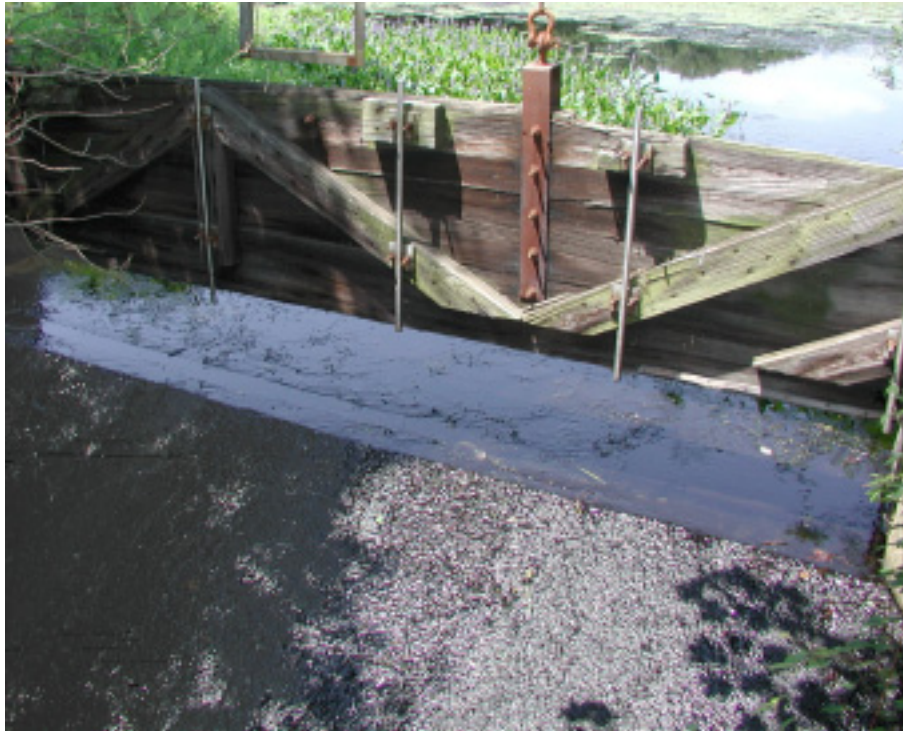
River Mile	Type	Material	Spillway W (ft)	Spillway H (ft)	Impoundment Acreage	Year Built	Owner	GPS
3.0	Dam control structure	Concrete with wood and steel gate	20.0	7.3	5.5	1900	Montaup Electric Co.	41° 44' 43.847" N 71° 11' 32.530" W

Swan Finishing Dam

Fishway None

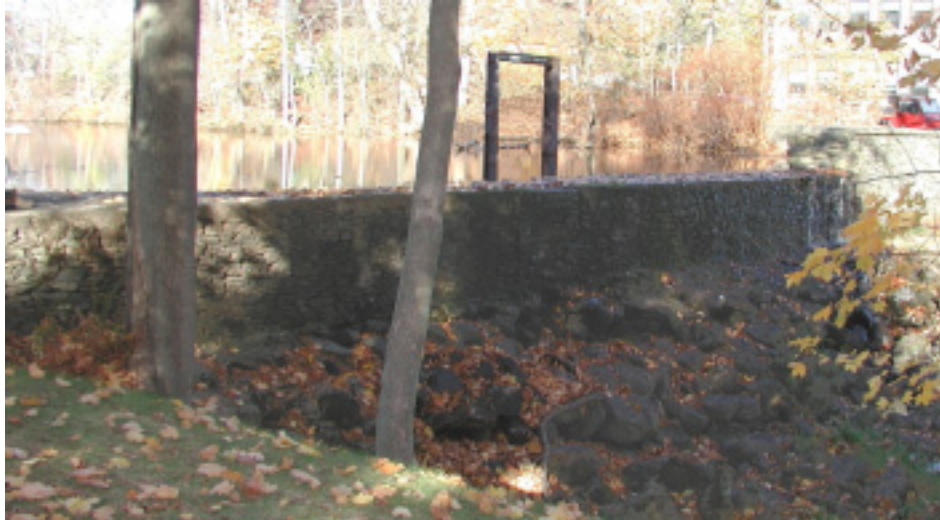
River Mile	Type	Material	Spillway W (ft)	Spillway H (ft)	Impoundment Acreage	Year Built	Owner	GPS
3.4	Dam	Stone and concrete	55.0	10.0	11.6	1900	Montaup Electric Co.	41° 44' 58.900" N 71° 11' 43.253" W

Lewin Brook Pond Dam

Fishway None
